**184/186, 188/190 & 194 Main Street South
Newmarket**

(GBCA Project No. 18038)

Conservation Plan

November 26, 2018
March 20, 2019 Rev. 1
March 25, 2019 Rev. 2

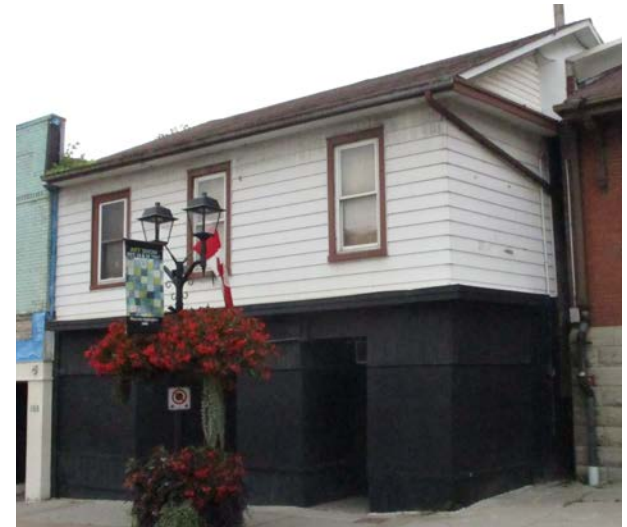
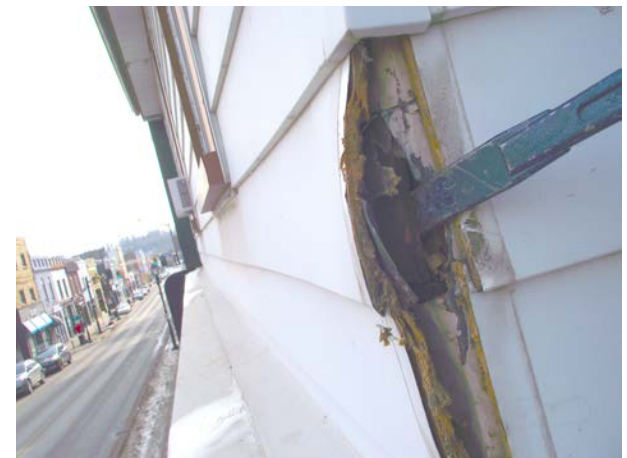
Building 184/186

The wall siding is in fair condition and consists of multiple layers of various materials which were applied at different time periods. The original siding material will be determined upon selective removals of the facade.

- Deteriorated asphalt shingles and deteriorated roof deck boards (unobserved, but typical condition). Refer to architectural drawings for new built-up assembly.
- Loose and/or damaged metal gutters and flashing.
- Original cornice missing.
- Original window sashes removed. Original frames are intact and in fair condition

- Remove and replace deteriorated asphalt roofing and roofing accessories
- Remove redundant wall siding and establish original siding material.
- Remove metal flashing to facilitate wood deck repairs and install new metal flashing.

- Replace existing flashings, gutter and rain water leaders with new - appropriate for the period of the building.
- Design and provide new replica wood cornices and pilasters that match as closely as possible the original configuration.

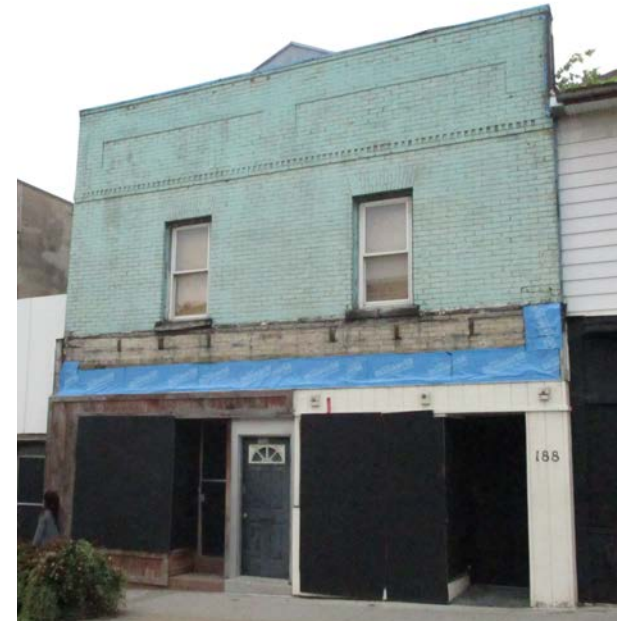
Building 188/190

The exterior wall assembly consists of a single wythe buff coloured brick on wood stud framing. The interior of the wall is plaster on wooden lath. The exterior elevation has been painted green and was found in fair condition outside the lines of screw-hole damage from the removed wooden battens. The original parapet is missing and the current parapet is severely deteriorated.

- Wall displacement and cracking at three locations; on the north and south ends above supporting beam and along full length of existing parapet
- Spalling/screw-hole fastening damage throughout entire wall. Due to prior metal siding installation.
- Green paint applied to entire brick wall.
- Missing original parapet from top to wall. The peaked roof behind is exposed.
- Original window sashes removed. Original frames are intact and in fair condition.
- Original cornice and pilasters missing. Original wood outriggers supporting original cornice remain - although truncated to facilitate installation of metal siding (now removed).
- Minor mortar joint deterioration throughout brick area.
- Dislodged and/or missing bricks along with diagonal cracking at window corners.

Repointing will match the profile, width and colour of the original mortar joints. Appropriate mortar (compatible in strength, porosity, absorption and vapour permeability with existing masonry units) to be used as per heritage Specifications and Restoration drawings. Areas of that have cracked and/or deteriorated we recommend repair, replace and re-point areas as noted on attached restoration drawings. A mock-up of selected cleaning technique for the Heritage consultant to review. The approved mock-up will serve as the standard of cleaning for the remainder of the work.

- Fill large holes with restoration repair mortar that matches the brick or mortar being repaired/filled.
- Repair and re-point areas of mortar deterioration. Percentage of re-pointing is annotated on drawings. Repointing will match the profile, width and colour of the original mortar joints. Appropriate mortar (compatible in strength, porosity, absorption and vapour permeability with existing masonry units) or to be used, as per heritage specifications and restoration drawings.

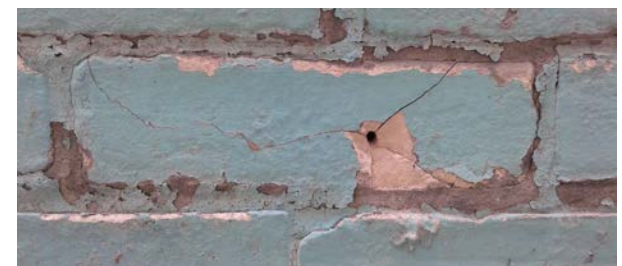
Screw-hole from wood battens

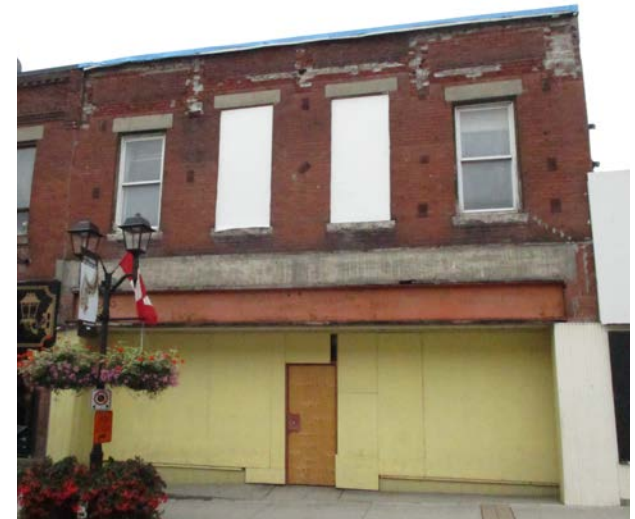
Building 194

The exterior wall assembly consists of double wythe red brick with some limited stone details, such as the window sills and lintels. Minimal ornamentation on the buildings are achieved through variations in brick patterns. Bricks are keyed into stone detailing, where present, sloped ledges and corbeling occur at chimneys and stepped brick parapets are coped with clay tile caps..

- Several ferrous anchors are distributed throughout the wall. Small anchors appear to be redundant, larger plate anchors appear to be retaining the brick in place.
- Oxidation has migrated from resulting penetrations.
- Severe removals damage at the top of wall on the facade elevation. Due to prior metal siding installation.
- Original window sashes removed. Original frames are intact and in fair condition.
- Original cornice and pilasters missing.
- Minor mortar joint deterioration throughout brick area.

- Remove misc. items from masonry (electrical, wiring, metal anchors, etc) and repair damaged bricks as detailed in the drawings and specifications.
- Dismantle and replace damaged bricks or wall assemblies with bricks that match the original in size and colour.

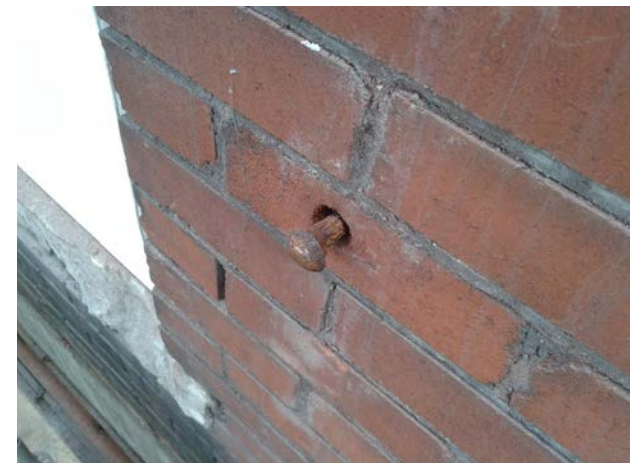
Ferrous Anchor

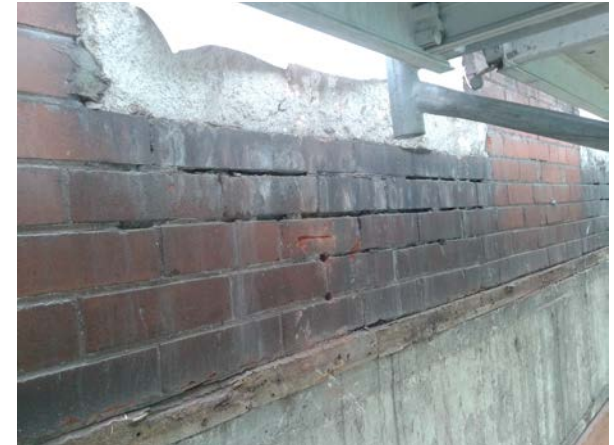
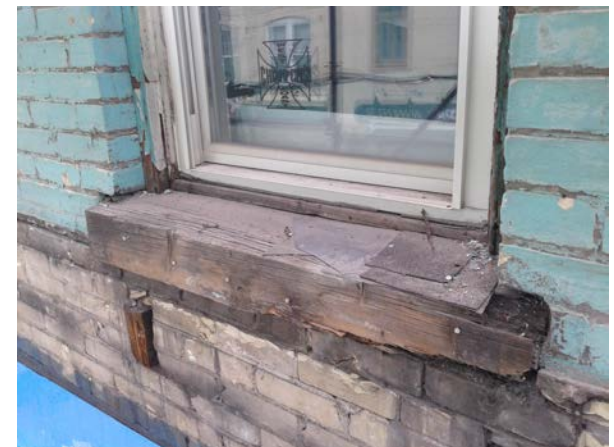
The condition of the majority of window frames throughout the 3 buildings is fair. The frames in building 184/186, however, need further review upon removal of existing siding - at this time it should be assumed that they are in less than fair condition since mostly concealed behind siding material. The wood sills in building 188/190 are severely worn in some areas and full replacement is the most feasible direction. The bottoms of the brick moulds are in good condition with exception to the bottom 150mm which should be cut and replaced with a replacement section ("dutchman"). The condition of the concrete window sills in Building 194 is poor. All of the windows sills have been chipped flush with the brick face to accommodate previous metal siding installation. They would have projected about 50mm beyond the wall. Originally, they may not have had a drip edge. This is likely the cause for the water staining and mortar deterioration immediately below the sills.

Typical condition of wood and stone window sills

- Remove all modern window frames and provide new replica sashes to match existing frame opening, double glazed w/ weather stripping. Repair existing wood frame and provide replacement components as indicated.
- Replace all lug sills with new to match existing.

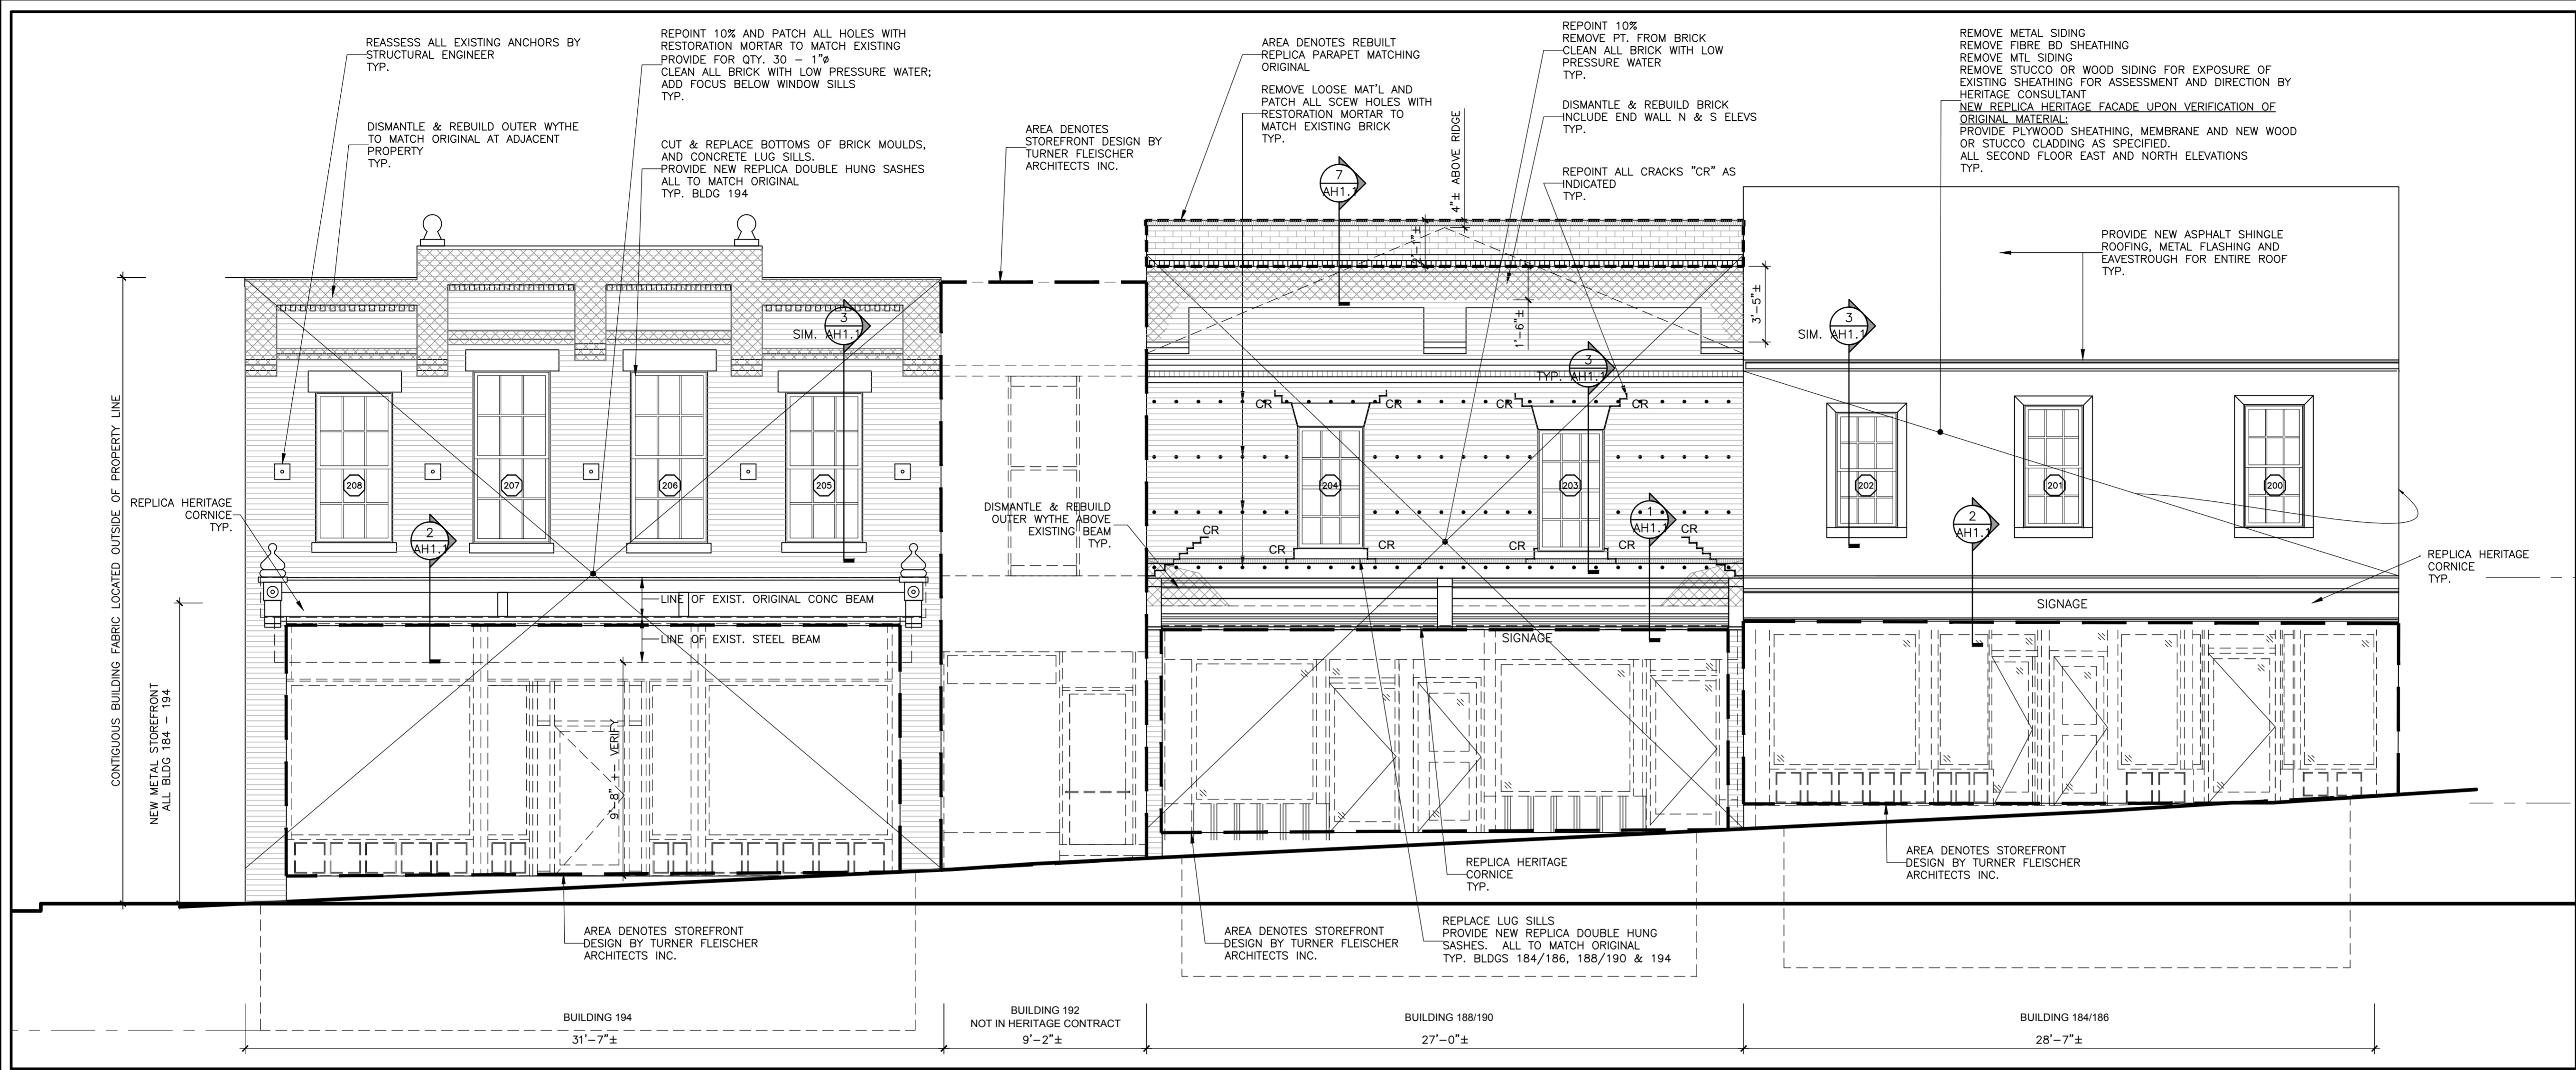
1 EAST ELEVATION
1/4"=1'-0" Bldgs 184/186, 188/190, 194

1 REMOVE EXISTING METAL CLADDING AND RE-ASSESS LUG SILL AND CASING CONDITION
