## **DEVELOPMENT AND INFRASTRUCTURE SERVICES/PLANNING & BUILDING SERVICES REPORT 2018-43 Information Report**

The purpose of this report is to provide Council with an update on the Bogart House located at 16920 Leslie Street which is designated under the Ontario Heritage Act and within the proposed development lands and applications for Official Plan Amendment, Zoning By-Law Amendment and Draft Plan of Subdivision approval for 16920 and 16860 Leslie Street by Forest Green Homes.

# HISTORIC STRUCTURE REPORT FOR 16920 LESLIE STREET FINAL

16920 Leslie Street,  
Newmarket, ON, L3Y 9A6  
13 September 2018  
13-119-04

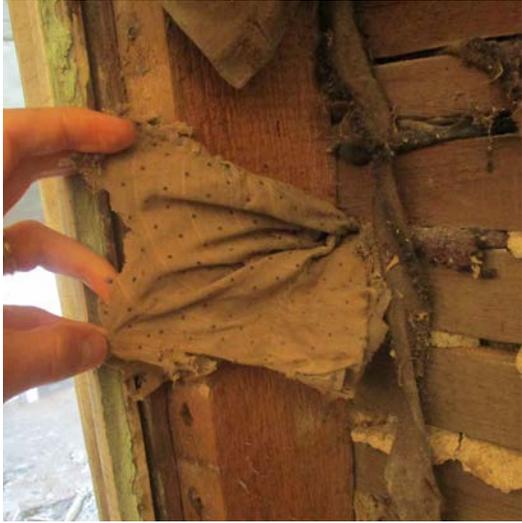
Cloth from clothing found embedded in lath and plaster (ERA).

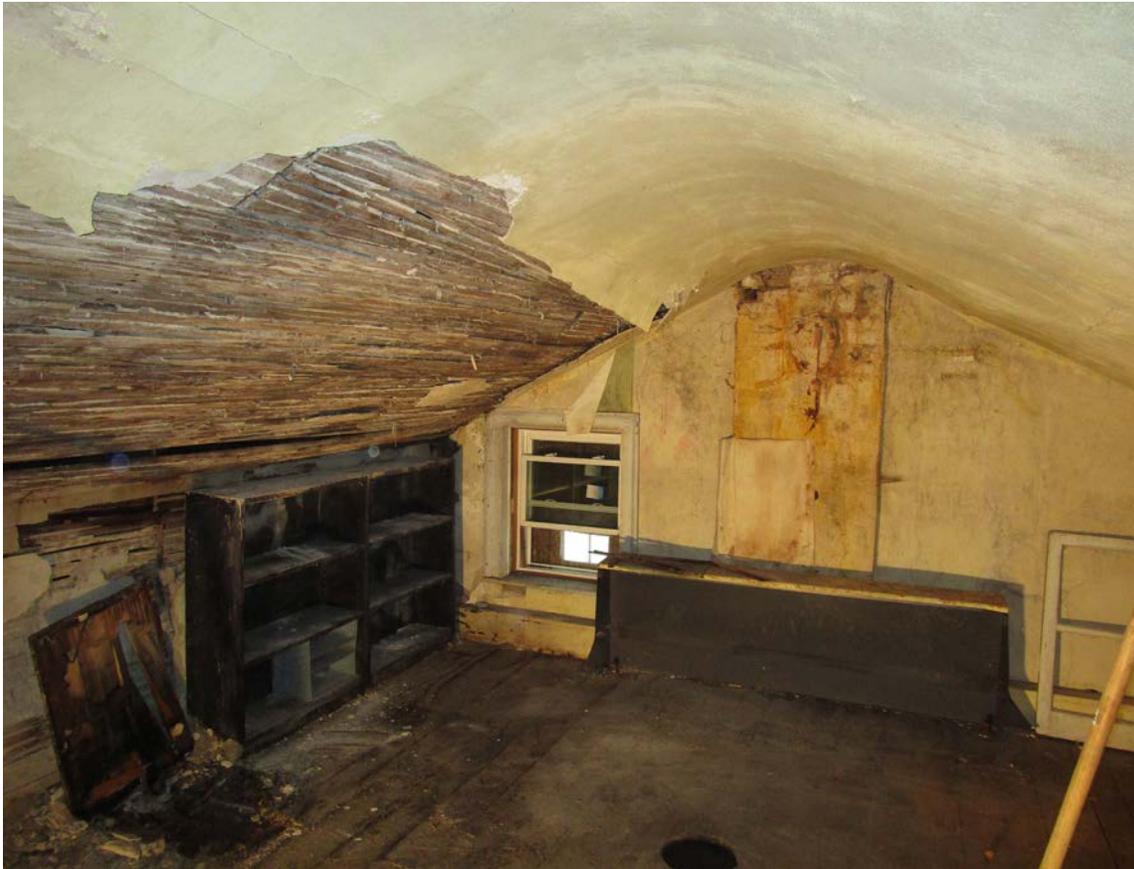
Condition of second floor of brick extension, (ERA).

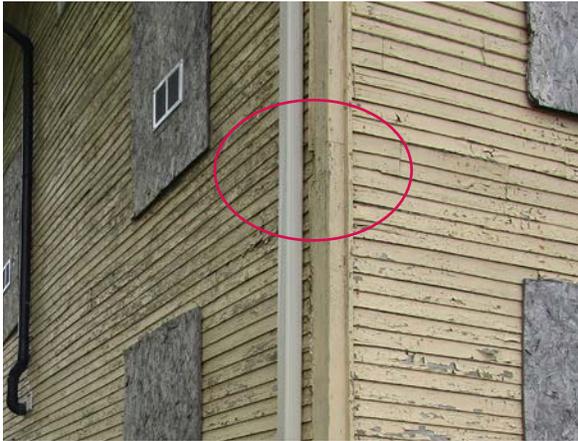
Patching of original trim on East elevation where the porch was removed (ERA).

Porches, often wrap-around on multiple elevations, were a common feature of the Regency Style, intended to give a house a greater sense of size and presence, and to connect it to the outdoors. There is evidence of a porch on the street elevation of the Bogart house only. Small repairs to the corner wood trim indicate where a roof structure to a single-storey porch would have connected to the house. Further evidence is likely concealed behind the 1970s exterior wood cladding. The partially buried remains of the concrete block foundation in front of the house most likely still reflect the planform of the former porch. The Regency porch would have been constructed in wood, including a suspended wood floor, raised higher above the garden grades, which may have risen as much as 500 mm in the last 2 centuries.

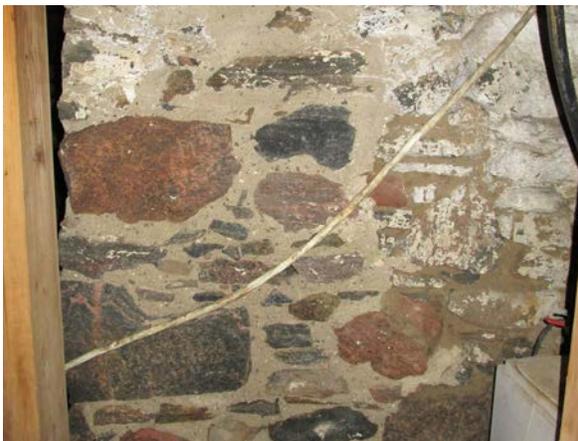
Cellar walls. Note lime rich mortar from later addition next to softer and darker mortar from earlier construction(ERA).

The foundation walls in the cellars are constructed of various sizes of field stone in random rubble coursing. The foundations of the framed house are constructed with mortar that is darker in colour and softer than typical lime mortar, with a clay-like texture. The foundations of the cellar of the brick extension have a harder mortar lighter in colour, indicating a higher lime content. This suggests that when the construction of the brick addition at the rear started a better source of limestone for burning for mortar had been located in the vicinity.

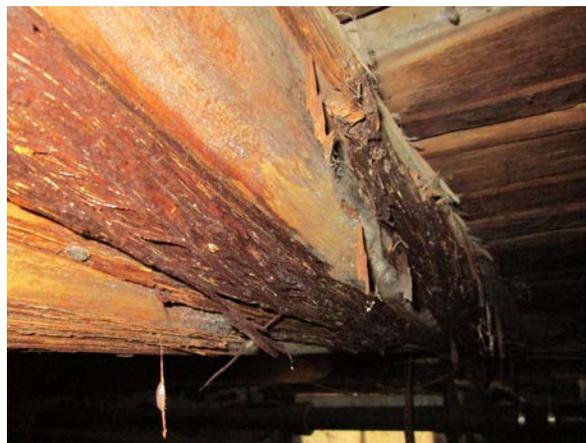
Bark on log joists in cellar (ERA).

The ground floor structure of the framed house and addition, over the cellar, consists of 9-10" diameter log joists. These joists are damp, and soft, and infested by Deathwatch Beetle. Some of the joists still have the bark on them. This indicates that they are not re-used timbers, but part of the original build. The joists bear on heavy timber mud sills, which also show areas of decay.

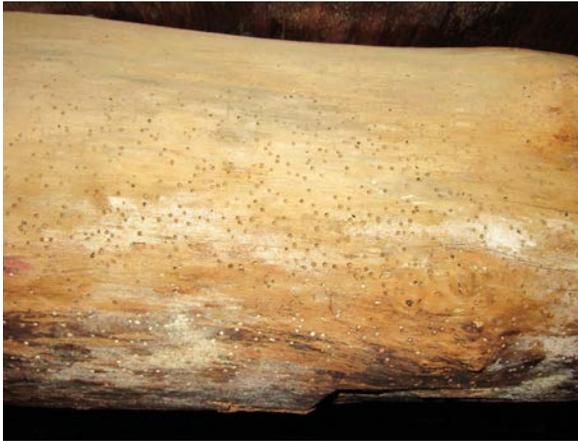
Deathwatch beetle holes in log joists (ERA).

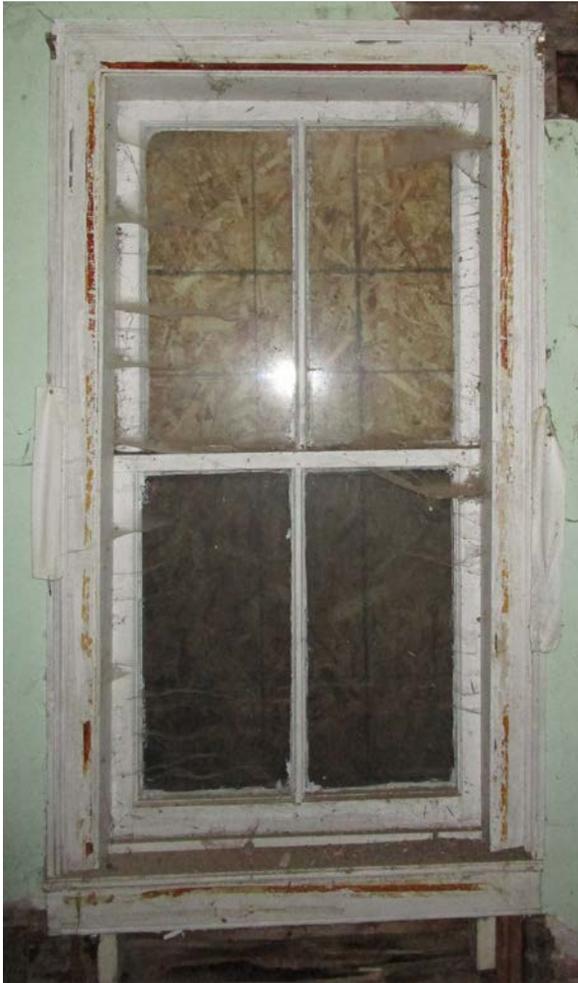
The window openings on the ground and second floor of the framed house are original, with original solid wood frames and small, finely moulded wood trim. The 2 over 2 wood sashes are not original. These sashes have wide muntin bars indicating that they are of late 19th century origin.

Ground floor window, with simple trim and 2 over 2 not original wood sash (ERA).

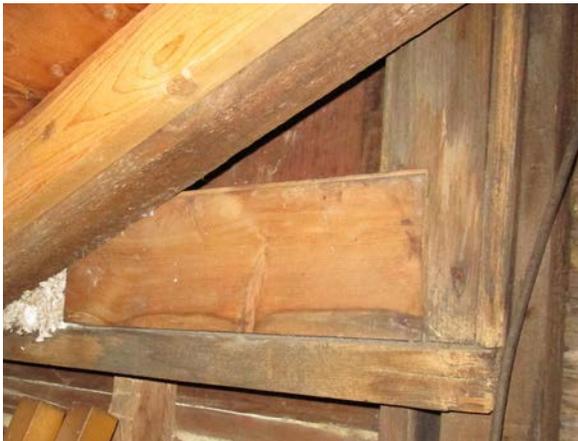
There are two windows visible on the second floor in the framed house that have been blocked in by the brick extension, and built over. One of these two windows still has its exterior sill in place, as well as part of its exterior vertical frame. Both of these softwood pieces are finished external parts of the window opening, yet are not painted. This would imply that the rear brick extension was constructed soon after, or before the framed house was finished, as it would be unusual to not paint a finished exterior softwood frame. It is also unusual for these not to have been removed and re-used for the later addition, as is evident on the one other blocked window found on the West elevation. The windows of the addition have similar solid wood frames and sash with simpler mouldings in later sash.

Blocked up finished window to framed house in roof crawl space of brick extension (ERA).

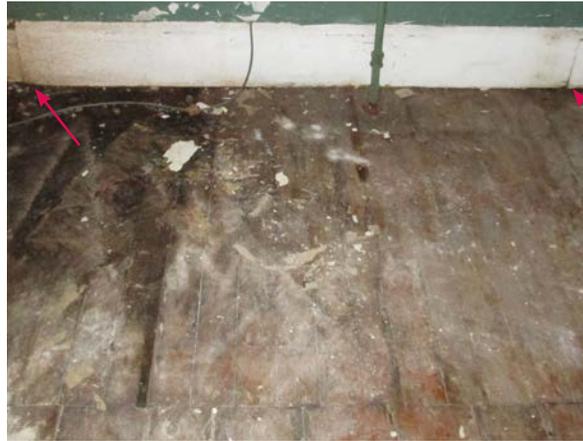
The hearth (since removed on the ground floor of the addition), is the only means of cooking identified. The support for the hearth still exists in the cellar, and the framing has been trimmed around to create an opening. The floorboards on the ground floor show an infill section where the hearth stone would have been. The large size of the hearth stone indicates a large, wide cooking hearth.

Flooring infill repair where hearth has been removed on ground floor of brick extension. Note visible lines in baseboard where baseboard has been inserted into gap (ERA).

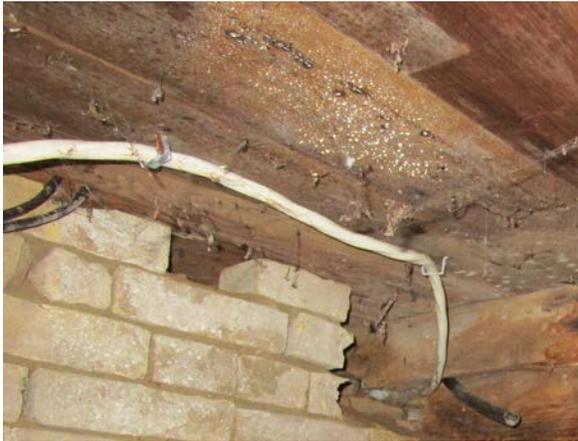
There are no clear signs of a stove in the original kitchen, although there are stone stub walls bonded into the exterior foundation, which carry a brick arch in the cellar directly below where a stove/hearth would have been located. It stops short of the floor structure, and there is no signs of change to the floor structure over, which shows no trimmers from a former opening.

Top of arched support in cellar. Note how it stops short of the floor structure (ERA).
