**DEVELOPMENT & INFRASTRUCTURE SERVICES - PUBLIC WORKS SERVICES  
INFORMATION REPORT 2017-11**

**TO:**                      Committee of the Whole  
**SUBJECT:**            Closed Waste Disposal Site x7016 – George Richardson Park  
**ORIGIN:**              Development and Infrastructure Services – Public Works Services

INVESTIGATION LOCATIONS  
 STAGE 2 SUMMARY REPORT  
 CLOSED WASTE DISPOSAL SITE x7016  
 Town of Newmarket, Ontario

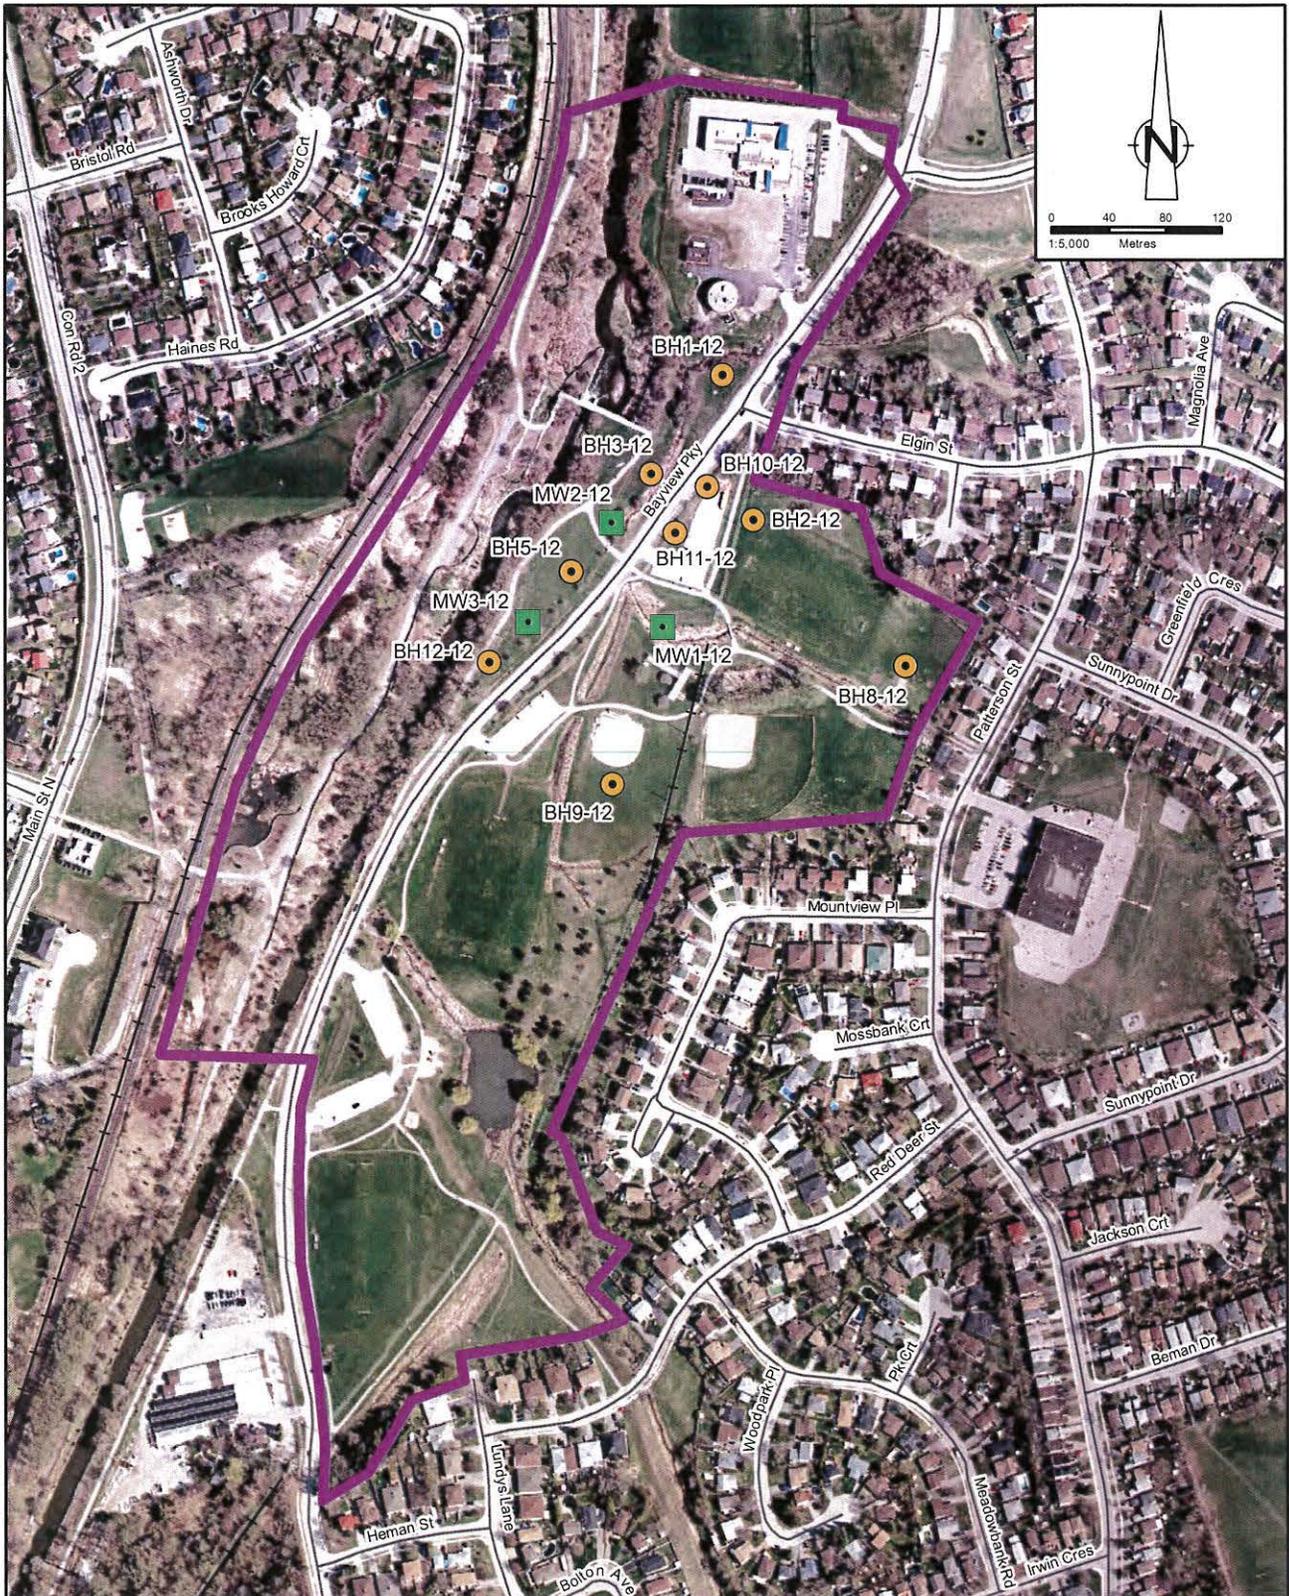
figure 1

Evidence of layers of buried refuse (indicative of historical landfilling) was observed within MW3-12, BH5-12 and BH12-12. As indicated on Figure 1 these boreholes are the three southern-most locations to the west of Bayview Parkway. Although there was minor evidence of occasional debris within fill materials at most of the other locations investigated, there was no evidence of actual layers of waste material that would be indicative of historical landfilling.

Based on the presence of layers of buried waste and the results of the soil quality sampling program, it is interpreted that the area of waste disposal at the Site is located in the vicinity of BH5-12, MW3-12, and BH12-12.
