**184/186, 188/190 & 194 Main Street South
Newmarket**

(GBCA Project No. 18038)

Conservation Plan

November 26, 2018
March 20, 2019 Rev. 1
March 25, 2019 Rev. 2

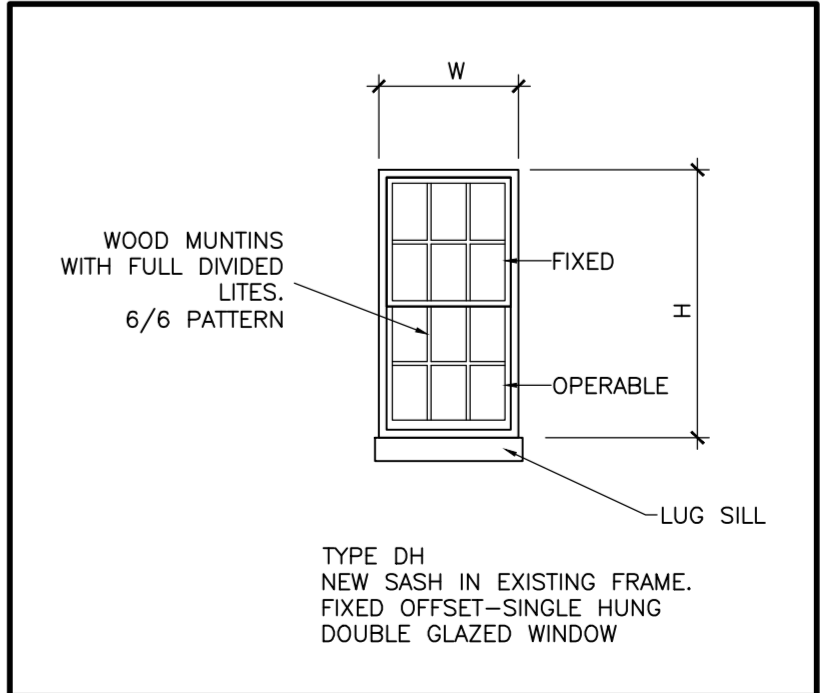
2 TYP. WINDOW
1/4"=1'-0"

1 REMOVE EXISTING METAL CLADDING AND RE-ASSESS LUG SILL AND CASING CONDITION

G4 REPLACE ALL EXTERIOR FRAME SEALANT AND BACKER ROD WITH NEW
