## **DEVELOPMENT AND INFRASTRUCTURE SERVICES/PLANNING & BUILDING SERVICES REPORT 2018-43 Information Report**

The purpose of this report is to provide Council with an update on the Bogart House located at 16920 Leslie Street which is designated under the Ontario Heritage Act and within the proposed development lands and applications for Official Plan Amendment, Zoning By-Law Amendment and Draft Plan of Subdivision approval for 16920 and 16860 Leslie Street by Forest Green Homes.

# HISTORIC STRUCTURE REPORT FOR 16920 LESLIE STREET FINAL

16920 Leslie Street,  
Newmarket, ON, L3Y 9A6  
13 September 2018  
13-119-04

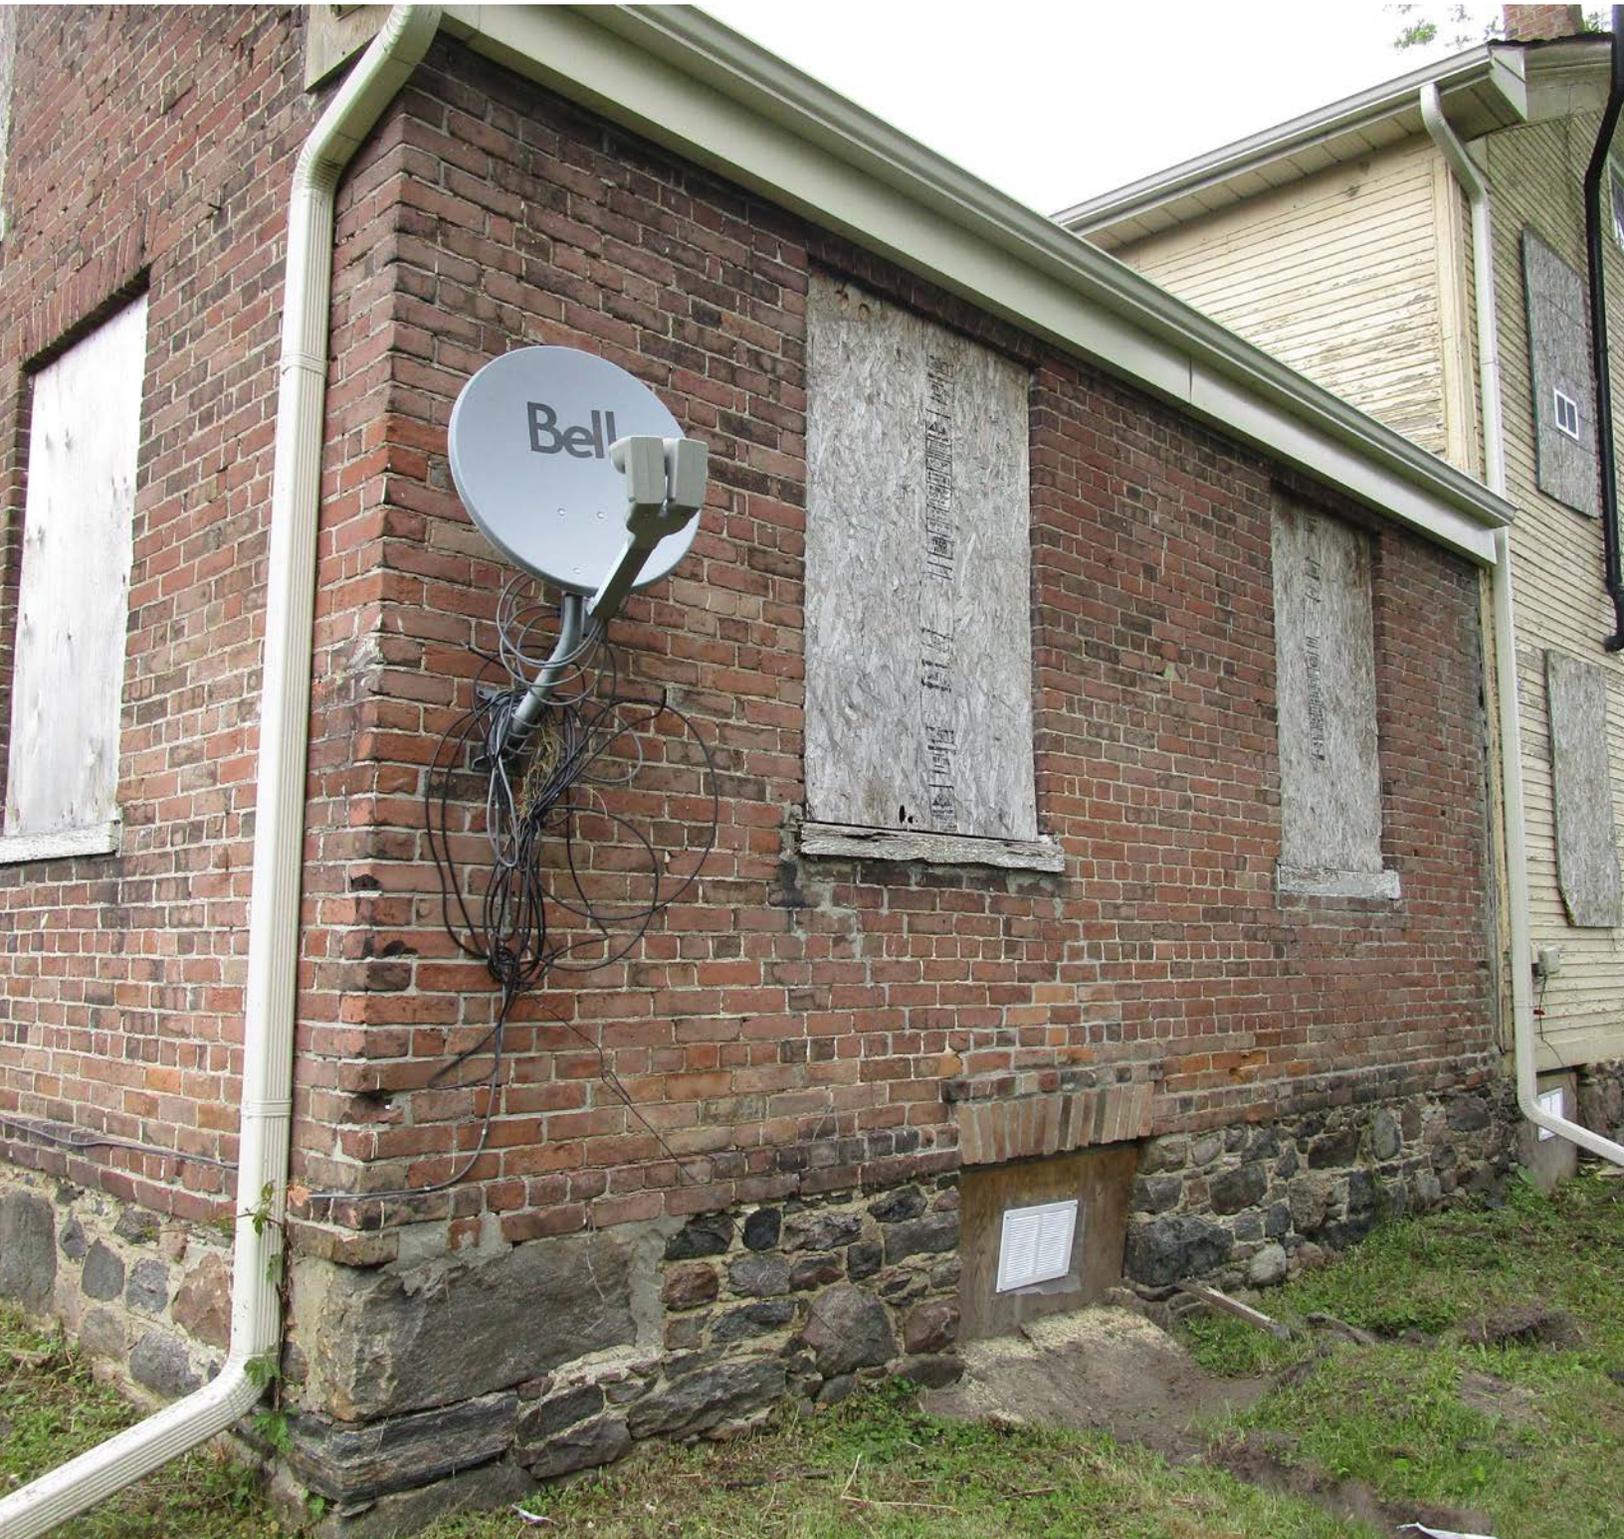
The fieldstone foundations and small bricks at the back extension from the South West (ERA).

The foundation walls in the cellars are constructed of various sizes of field stone in random rubble coursing. The foundations of the framed house are constructed with mortar that is darker in colour and softer than typical lime mortar, with a clay-like texture. The foundations of the cellar of the brick extension have a harder mortar lighter in colour, indicating a higher lime content. This suggests that when the construction of the brick addition at the rear started a better source of limestone for burning for mortar had been located in the vicinity.

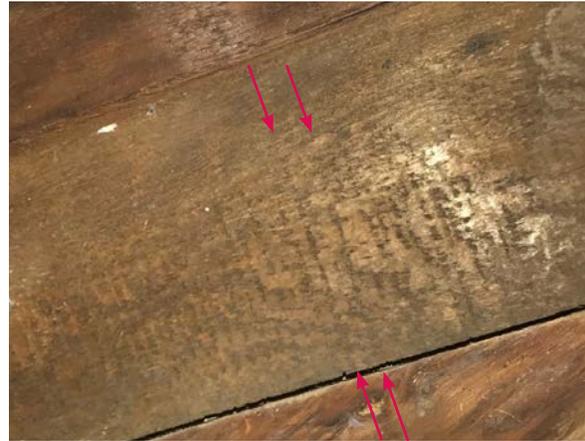
Bandsaw marks in wood on rafter in timber frame building (ERA).

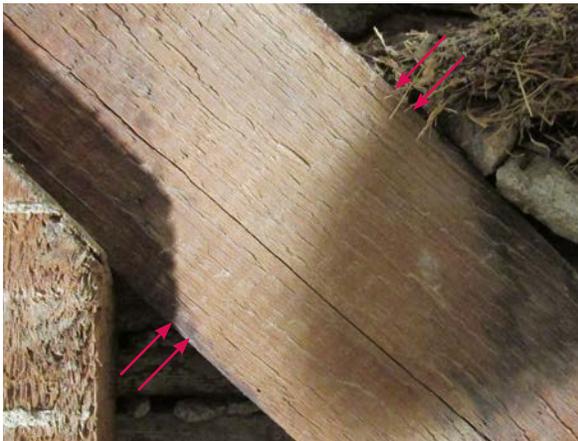
Bandsaw marks in heavy timber framing (ERA).

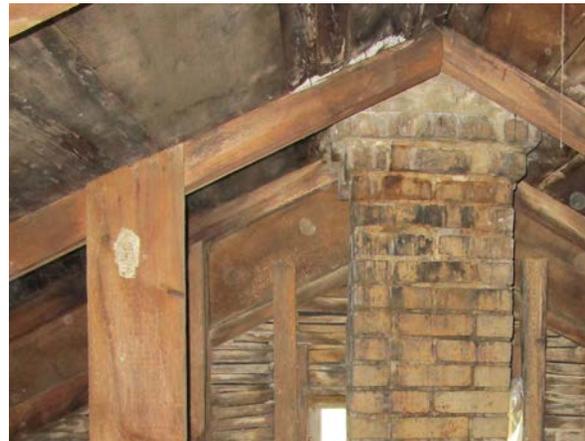
Tapered rafters, (ERA).

- Squared tapered rafters, approx 6" deep at wall plate, 3-1/2" at ridge at 30" on centre; birdsmouthed over head plate; no ridge board.
- Original 4" narrow deck boards at mid roof slope, with existing hand-made roofing nails, nailing pattern indicates originally roofed with wood shingles, 4" exposure.
- Top of slope later wider boards, plywood replacement at eaves

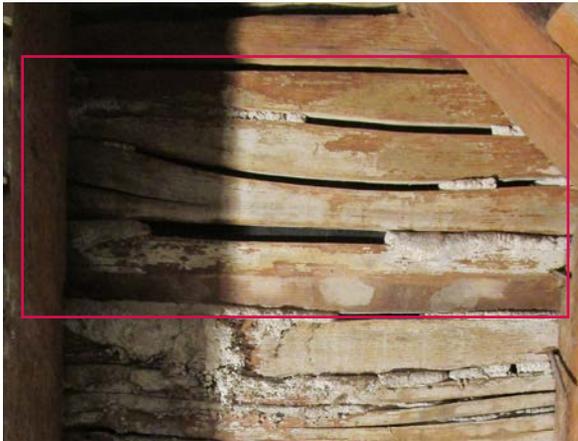
There is thick riven wood lath for the plaster throughout the house. It can be clearly seen that some of this hand split lath, in the attic, and the lath for the exterior stucco is accordion lath, created from large planks, usually 4 pieces of lath per plank. The lath on the interior has lime plaster with a high clay content and kid goat hair reinforcement. The lath on the exterior, which would have supported the stucco (rendered finish) has a lime-rich mix also with kid goat reinforcement. This stucco would have had corner trim with quirk (round) mouldings, been lined out to look like ashlar, and limewashed for colour and waterproofness. In all cases the lath is notably thick to span between the widely spaced wall studs.

Hand split wood lath (ERA). Note plank split into 4 pieces.

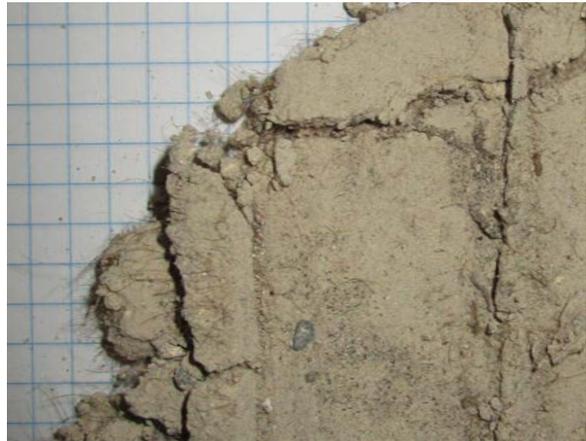
Close up image of interior plaster sample. Note higher clay content with hair reinforcement. (ERA).

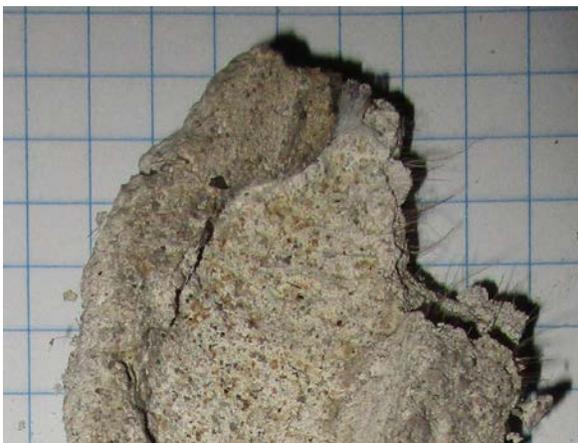
Close up image of exterior plaster sample. Note lighter lime rich render with hair reinforcement. (ERA).

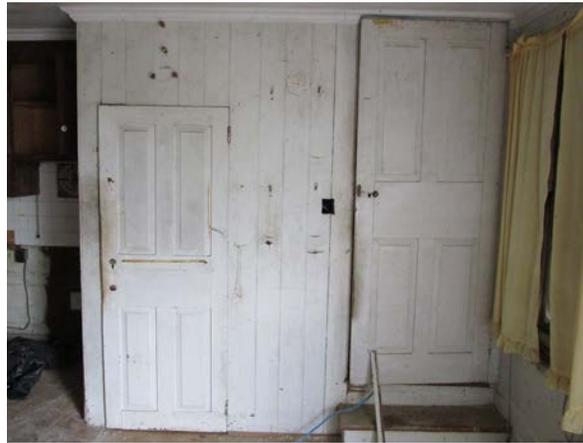
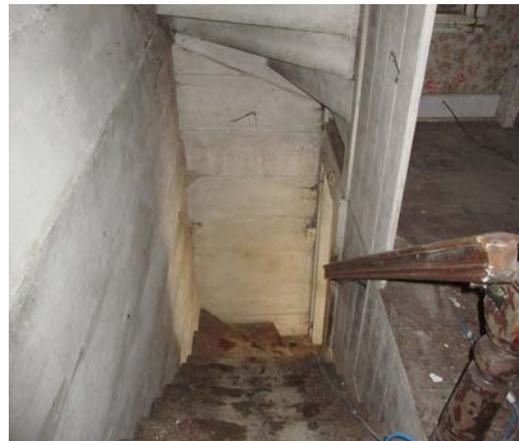
Enclosed closet staircase in framed house (ERA).

Closet staircase with multiple winders at the bottom (ERA).

- Closer risers with treads with integral round nosings, with multiple winders at bottom.
- Stair opening trimmer bears on summer beam just 4" from an unused birdsmouth cut out, to allow wider staircase.
- Very narrow cut stringer; suggests additional structure (multiple carriages) under the stair.
- Fine turned wood balusters found in house and attic, several still attached to a horizontal piece of handrail. So not on stair; probably protected open edge to second floor.
- Panelled stair enclosure with closet under stair.

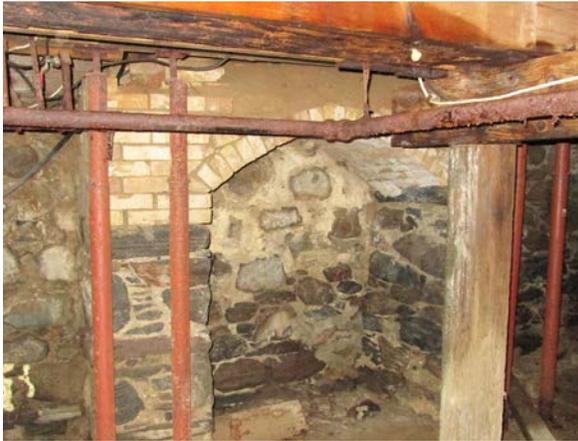
There are no clear signs of a stove in the original kitchen, although there are stone stub walls bonded into the exterior foundation, which carry a brick arch in the cellar directly below where a stove/hearth would have been located. It stops short of the floor structure, and there is no signs of change to the floor structure over, which shows no trimmers from a former opening.

Arched support in cellar (ERA).

- There is no clear signs of a stove in the original kitchen, although an arched support in stone, bonded into the exterior foundation, and brick exists in the cellar directly below where a stove/hearth would have been located. It stops short of the floor structure, and there is no signs of change to the floor structure over, which shows no trimmers from former opening.

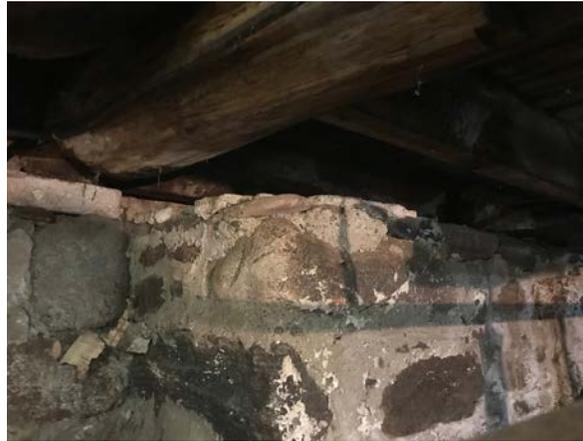
The hearth (since removed on the ground floor of the addition), is the only means of cooking identified. The support for the hearth still exists in the cellar, and the framing has been trimmed around to create an opening. The floorboards on the ground floor show an infill section where the hearth stone would have been. The large size of the hearth stone indicates a large, wide cooking hearth.

Base of hearth in cellar. Note framing around opening for hearth to extend into ground floor (ERA).

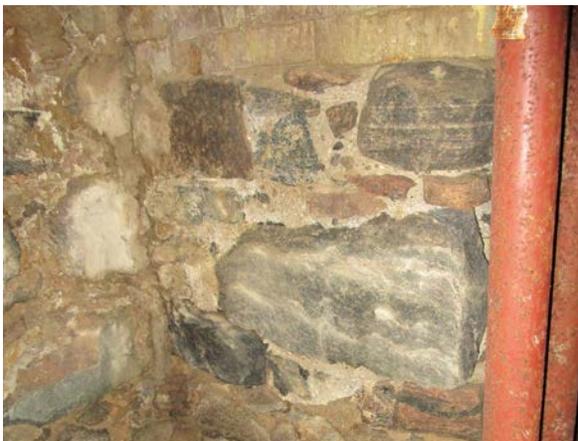
Lighter and harder lime rich mortar in upper courses of arched support (ERA).

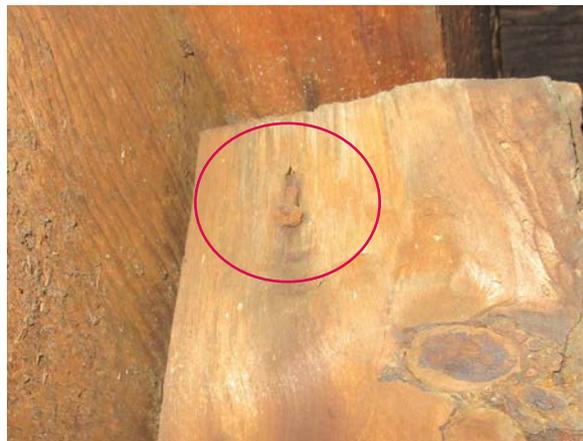
Rosehead nail in attic of timber frame building (ERA)

The nails found in the framed house and the brick extension are predominantly of the rosehead type. Rosehead nails are usually found in buildings constructed prior to the 1840s, when the cut nail (sometimes referred to as the square nail), became more commonly available. Cut nails are notably absent which suggests little change until the 1970s, when galvanised wire nails were used.
