Parklands at Mulock Drive and Bathurst Street Introduction and Background

Presentation to the Committee of Whole,

Town of Newmarket

FIGURE 1-2
TOWN OF NEWMARKET
PARKLANDS AT MULOCK DR. & BATHURST ST.
RISK ASSESSMENT

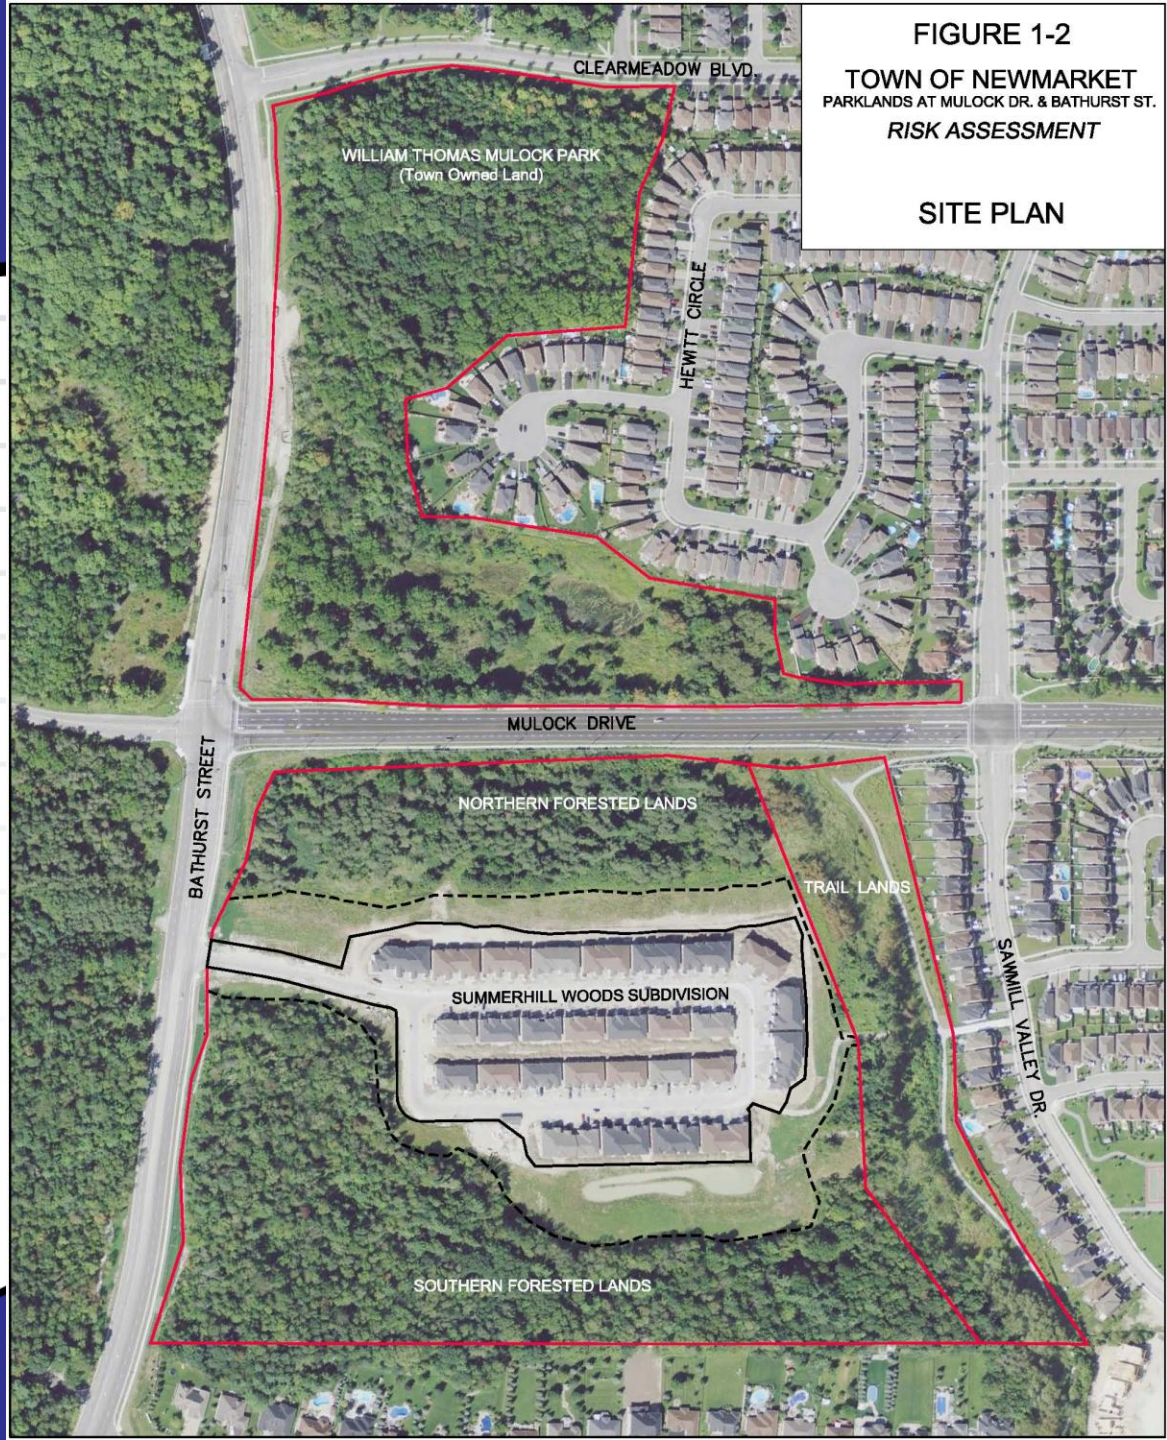
SITE PLAN
